Overview and History of the Russian River Watershed

Dr. Matt Kondolf

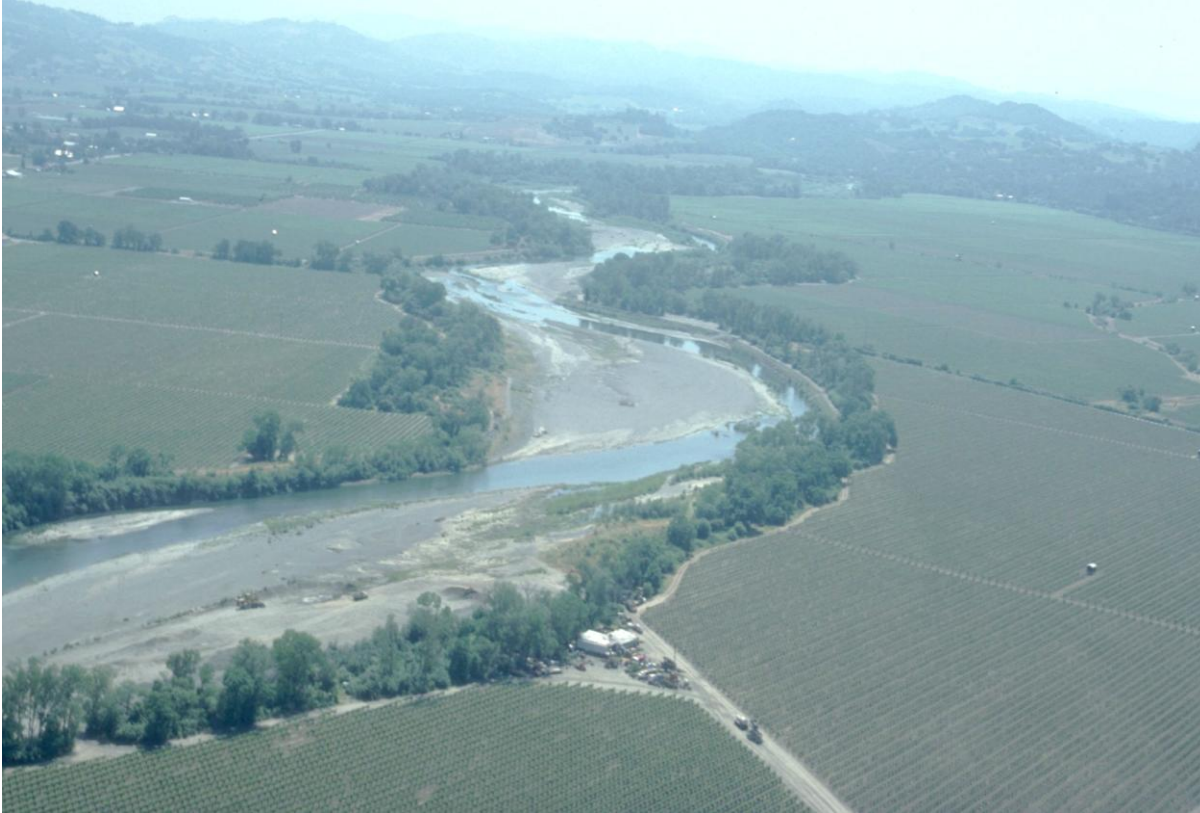
Russian River watershed is one million acres. Unlike most north coast rivers it has a series of alluvial river valleys – Redwood, Ukiah, Hopland, Alexander and Russian River Valley. Mountains border the sides of each valley.

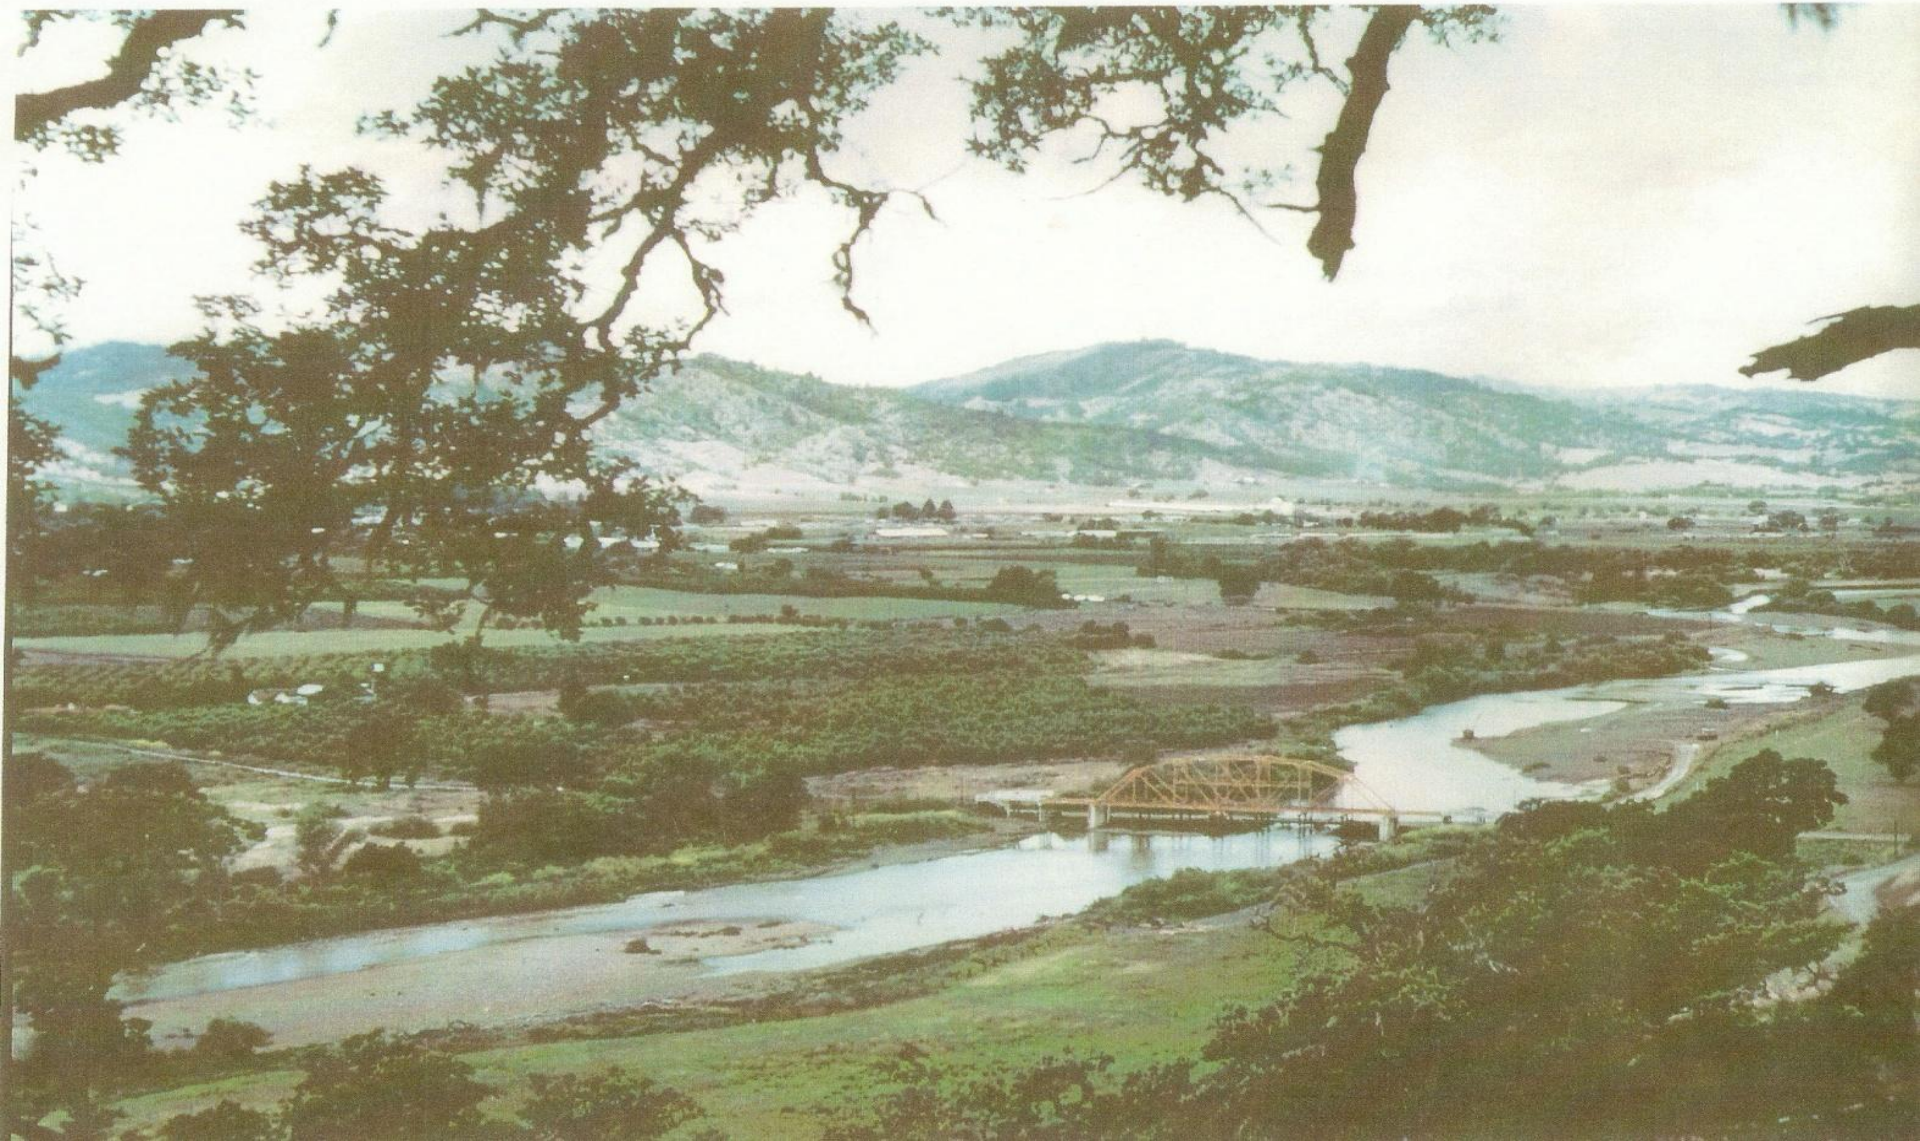
**Historical photograph of the Perkins St. Bridge over the Russian River in Ukiah Valley.
Note wide shallow channel (Early 20th Century)**

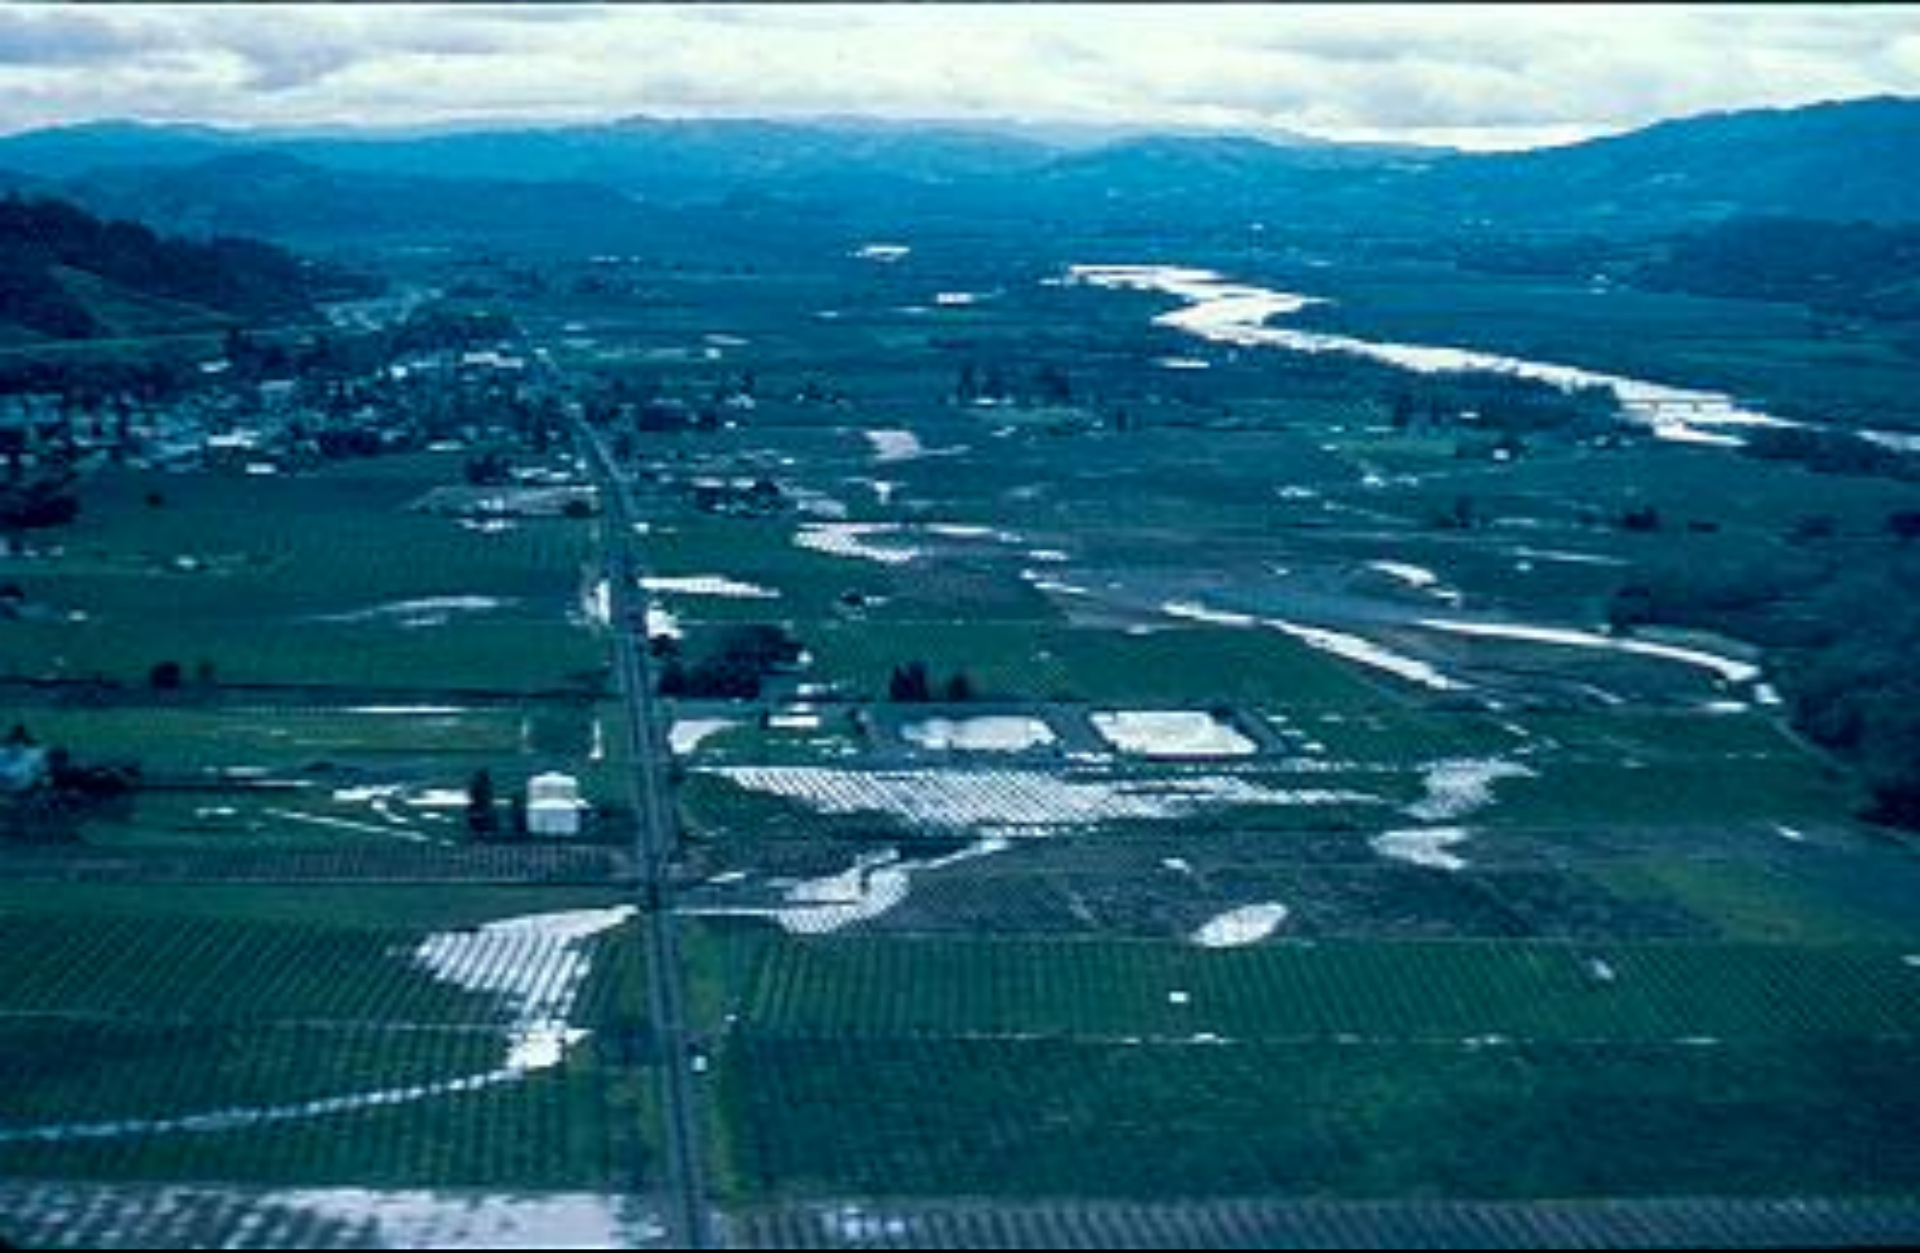
Post-flood view of Russian River shows old channels in floodplain

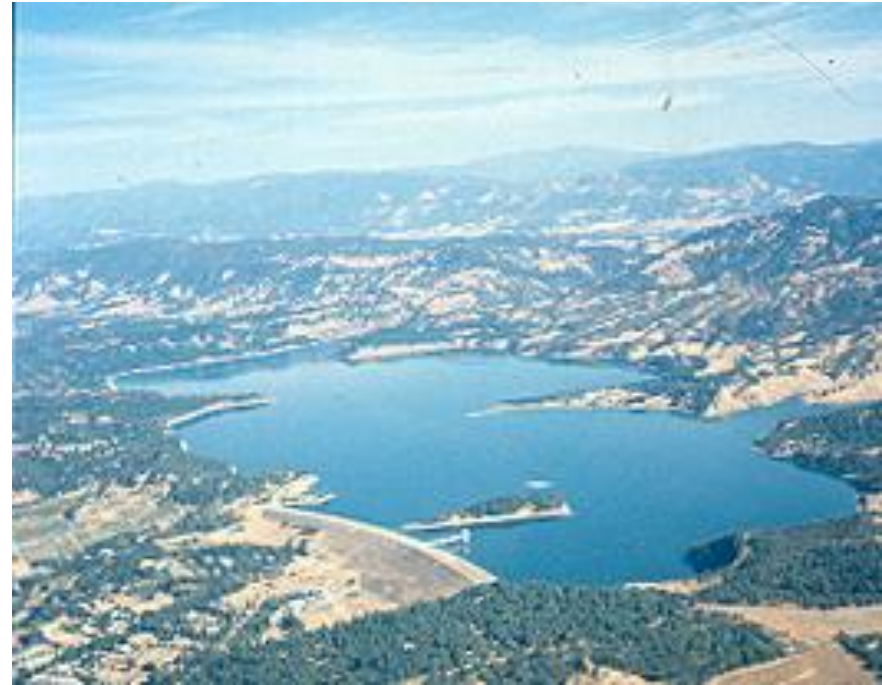
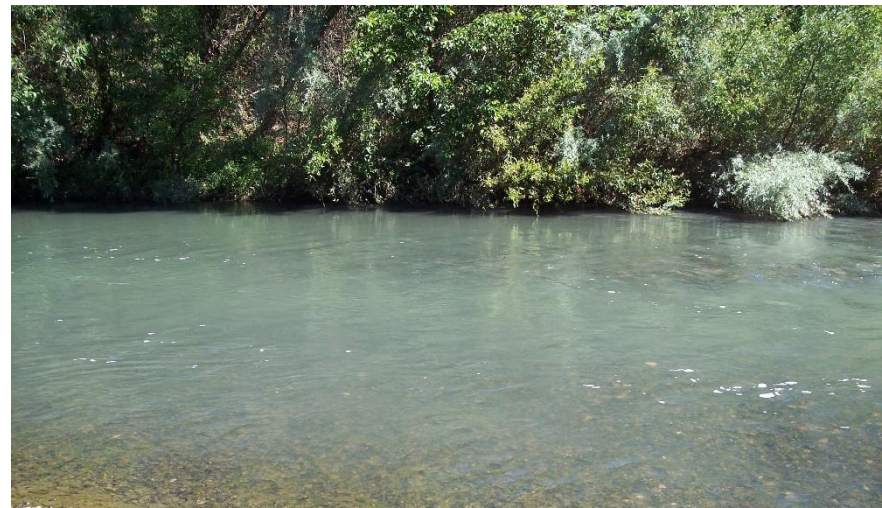
The Potter Valley Project was constructed in 1908 and Lake Pillsbury was constructed in 1922. Coyote Dam was constructed in 1959. Releases from Lake Mendocino provide summer flows to the Russian River.

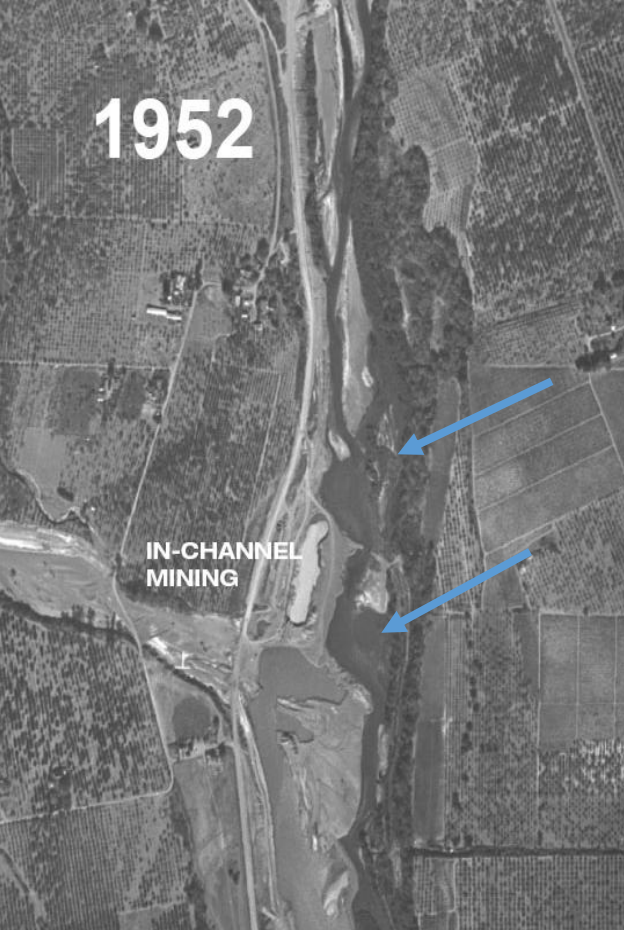
Gravel pit mining of the Russian River valley lowered the river bed by 20-50 ft. In 1981-90, 10 million tons of gravel were extracted from the river channel. Instream bar skimming and excavation of floodplain pits continues to be done. The Russian River continues to adjust to these major impacts.

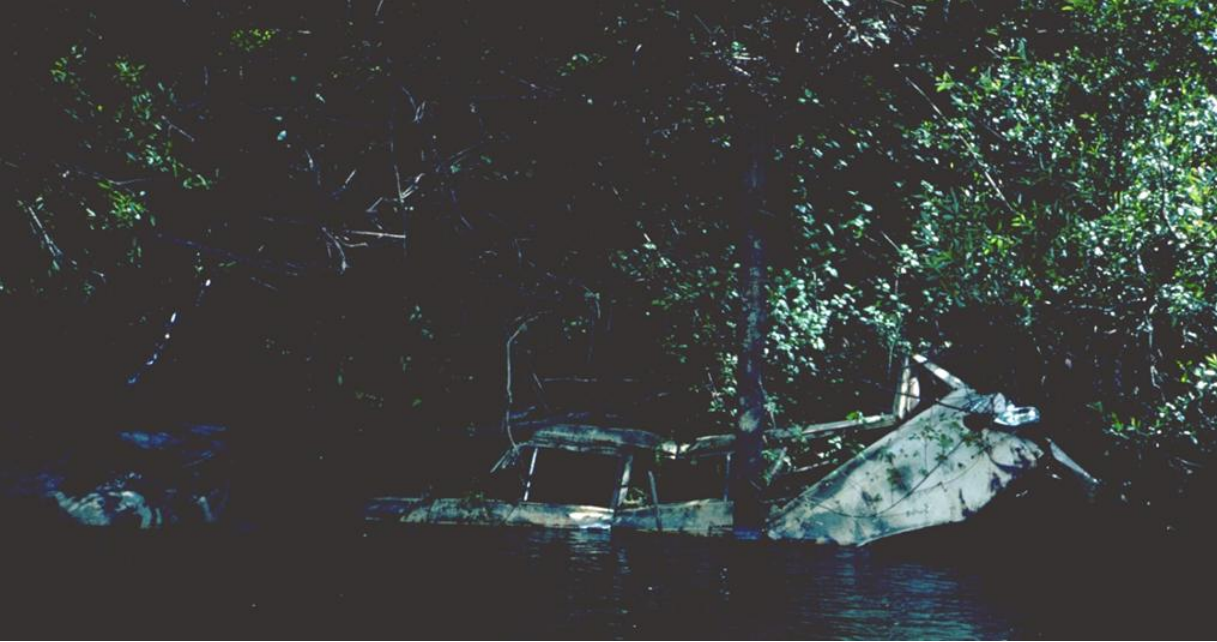
The use of car bodies to stabilize stream banks was recommended by the U.S. Dept. of Agriculture

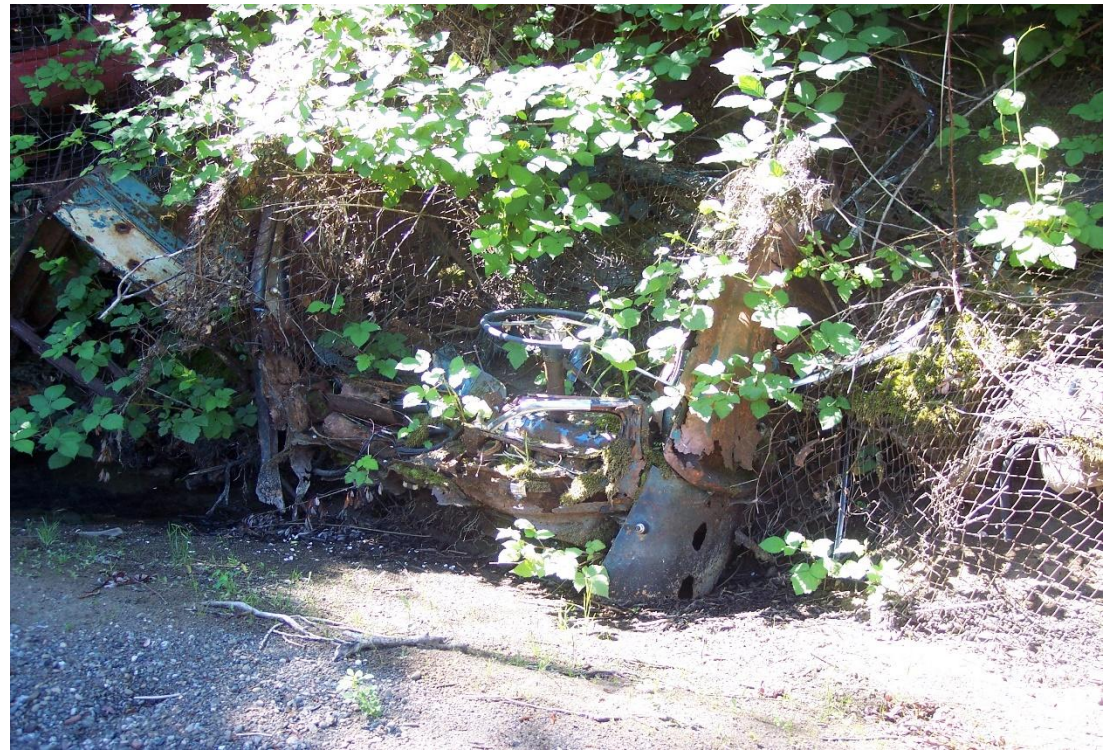
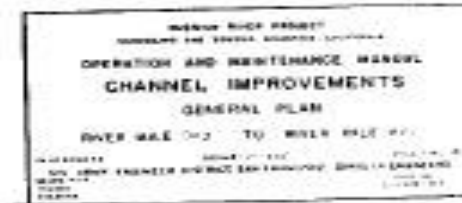
**Army Corps of Engineers
Russian River Channel Improvement Project
Ukiah Valley**

Army Corps of Engineers Constructed River Channel

Natural Meandering River Channel and Riparian Floodplain

Army Corps of Engineers Russian River Channel Improvement Project in Ukiah Valley 1956-1963

Over the Ukiah-Hopland-Alexander Valley areas of the Russian River, the Corps' project resulted in:

- 635 acres of channel clearing
- 210,000 cubic yards of channel excavation
- 10.8 miles of jacklines
- 4.4 miles of flexible fence
- 2.0 miles of willow planting with wire mesh (30 ft. wide strips)
- 11.3 miles of willow only planting (30 ft. wide strips)

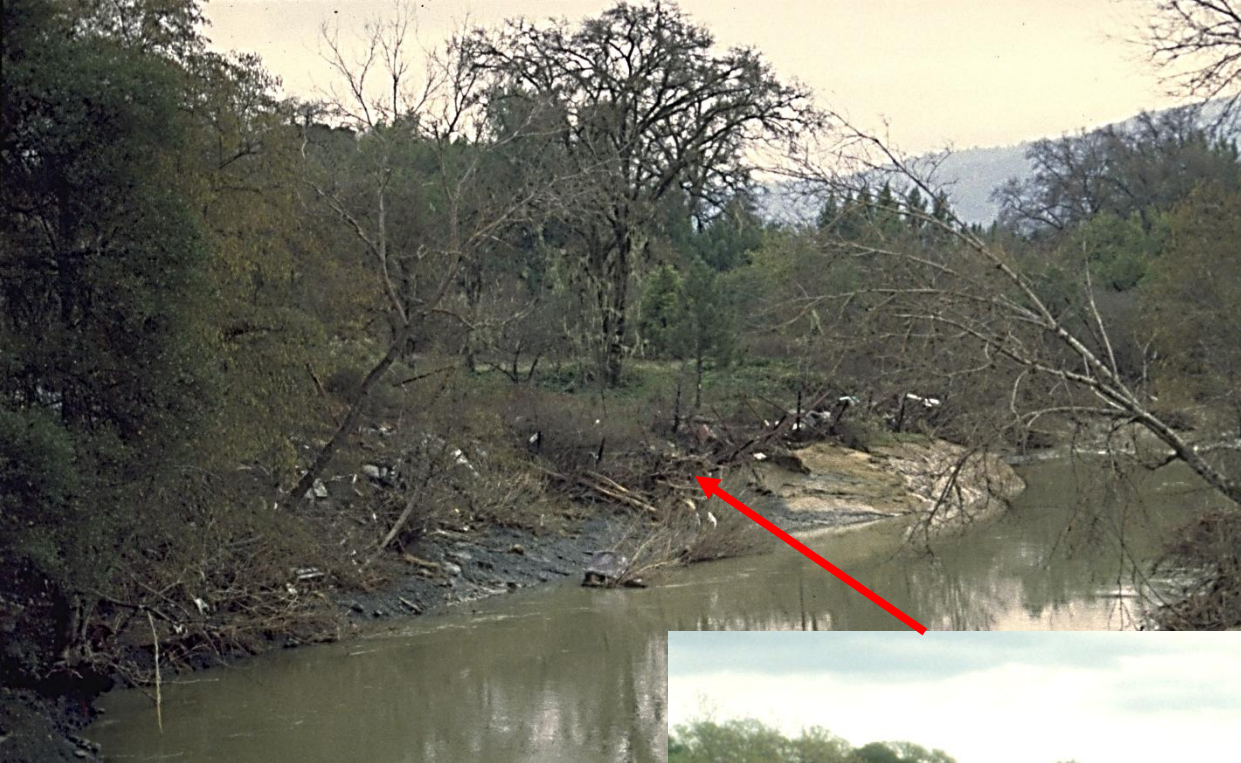
Jacklines installed as part of the Corps channel improvement project in the 1960s to protect banks have become debris in the river in some locations

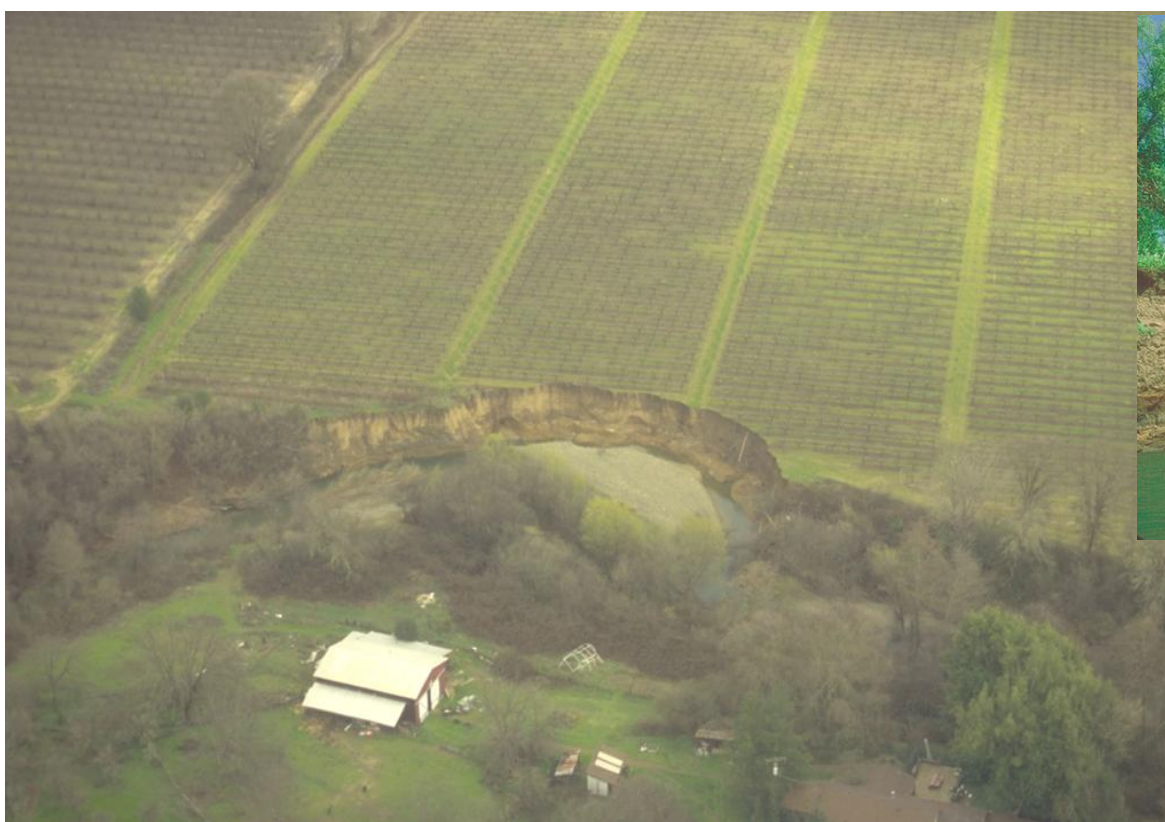
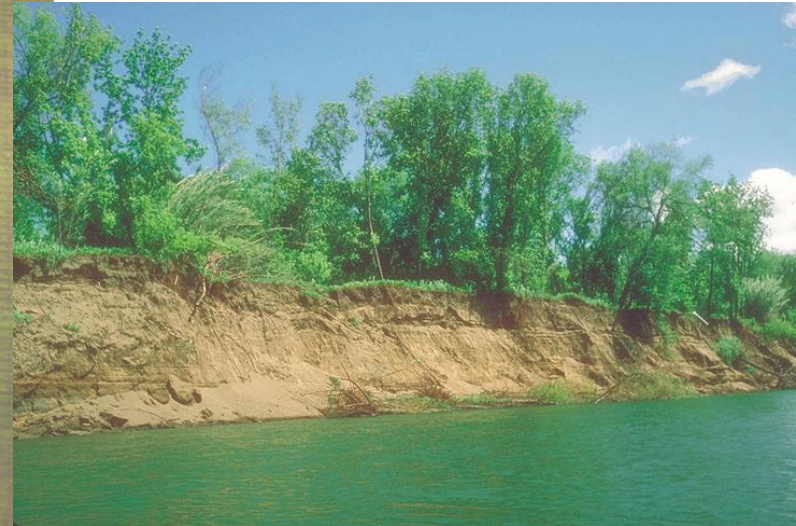
Incision in the Russian River in Ukiah and Hopland Valleys

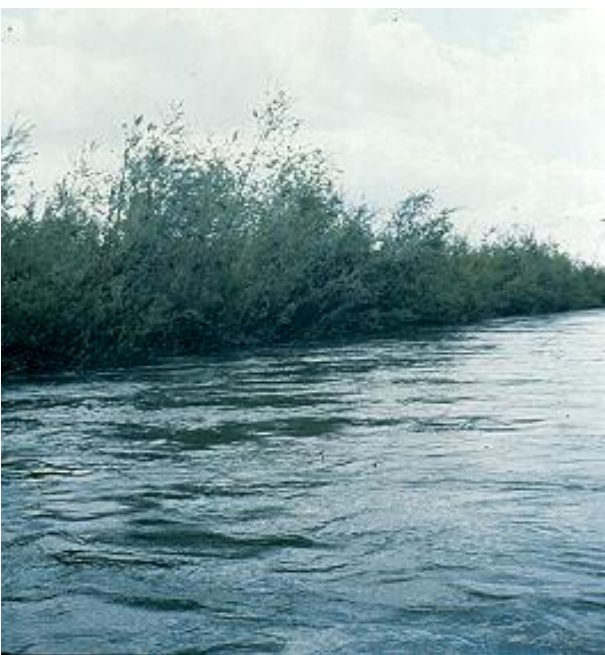
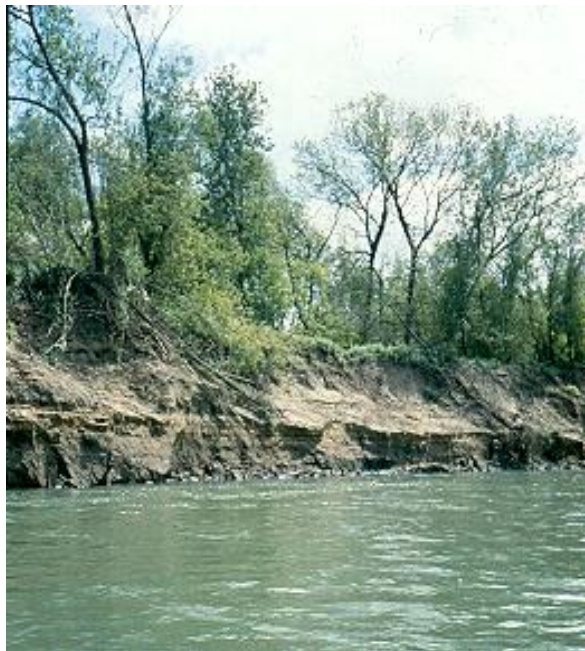
Flood releases from Coyote Dam following a major storm can cause bank erosion. The effects of flood releases on the geomorphology of the Russian River channel have not been studied adequately.

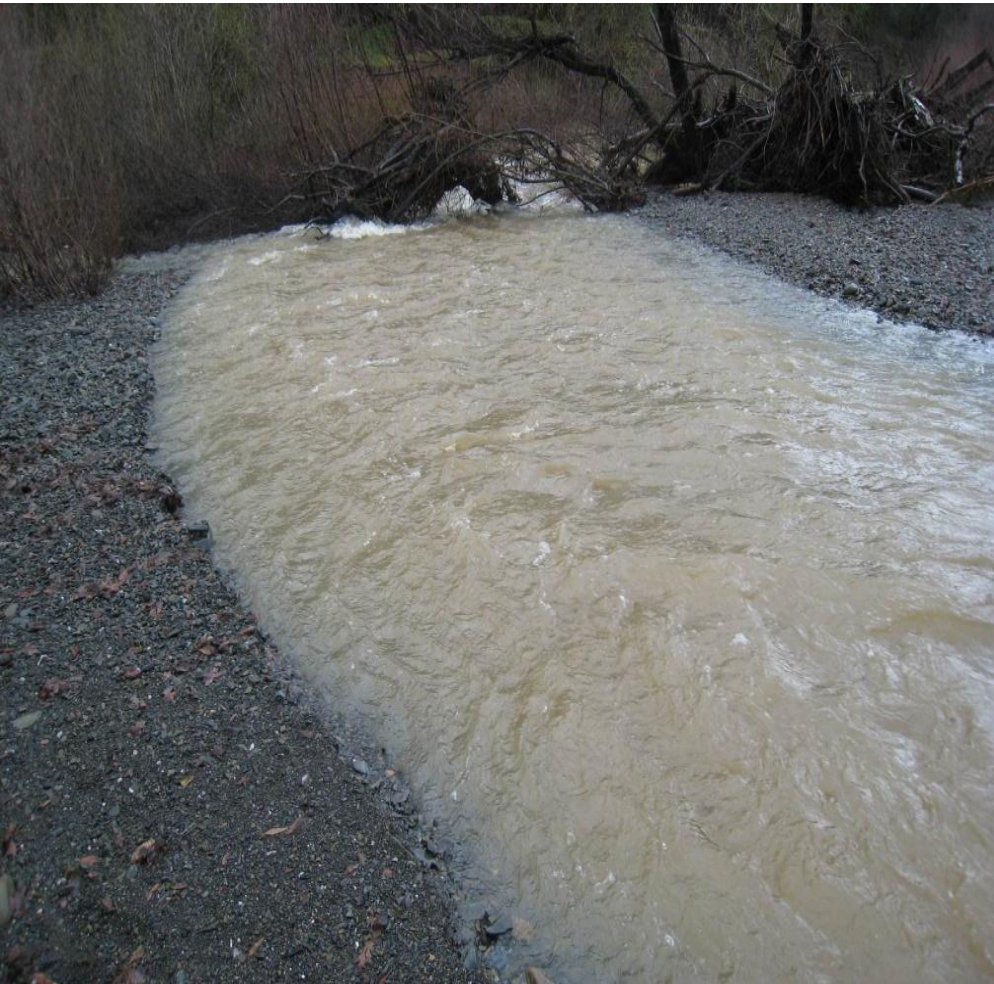
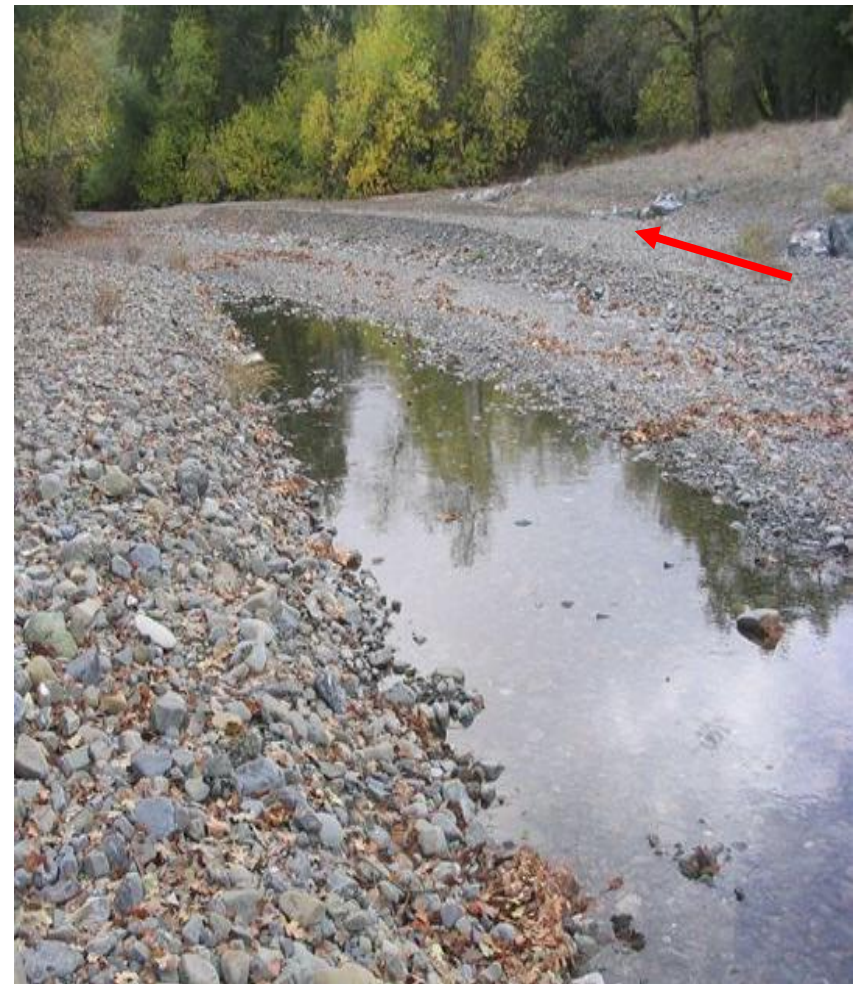
Morrison Creek flows to the Russian River channel when river stage is high but when river stage is low creek goes subterranean prior to reaching river

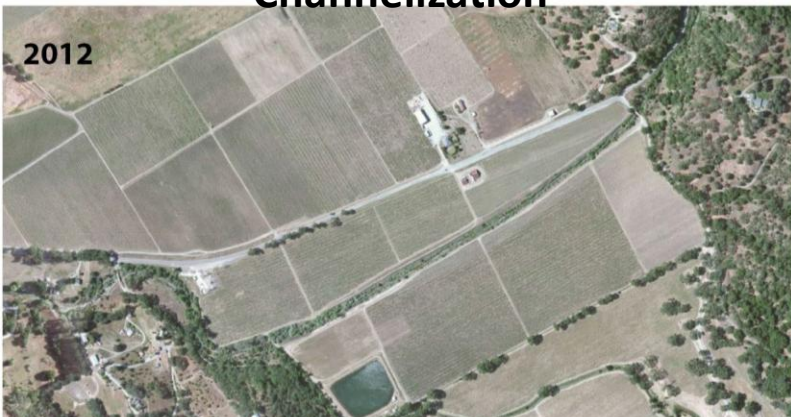
Channelization

Tributaries in the Russian River are affected by channelization, urbanization, on-stream dams, direct water diversions and channel incision
